Fire Incident Involving Laboratory "Oil Bath"

||| SAFETY ALERT

实验室"油浴锅"着火事件

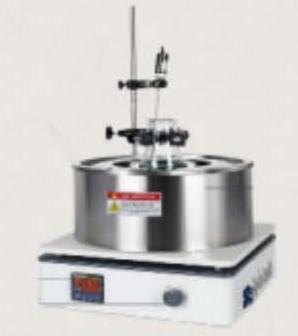
- 1.实验设备"油浴锅"(集热式恒温加热磁力搅拌器)因长时间工作,导致温控装置失效,温度过高引发火灾;
- 2.夜间高温实验无人值守, 无远程报警装置。

集热式恒温加热磁力搅拌器

- 1.经调查发现,上海岐*仪器设备有限公司、上海予*仪器有限公司等生产的 DF-101S集热式恒温加热磁力搅拌器,产品质量存在一定风险,提醒各位实 验室师生注意,严把采购和使用关,并落实设备定期运维。
- 2.过夜实验需先评估风险,做好防范措施,确保安全方可运行;从事反应性、高温、高压、真空、非密封性3B以上激光、使用实验流水等有机会失控可能导致严重后果的过夜实验(23:30-8:00之间),需填写《过夜实验申请单》,经PI签字,并报实验室安全员、安全主任备案。安全主任确认后,需通知HSE后方可进行。

- 将仪器放置于平稳、清洁、防滑、干燥和防火的台面,远离热源,不要堵住集热式恒温加热磁力搅拌器的通风口或散热窗。
- 根据搅拌介质的种类,选择合适的防护装置,以防可能会出现液体飞溅、释放有毒或可燃气体等危险。处理有毒、易挥发介质时,使用密闭容器并在合适的通风橱中进行。
- 仪器操作前,将调速旋钮旋至最小刻度。
- 严禁干烧! 小心高温! 切忌裸手触碰集热锅, 仪器关闭后也请注意余温。
- 定期更换集热锅內的加热介质;长期不用需将集热锅內的水或油排尽、擦干,电源拔下,并 放置在阴凉干燥处。
- 如果在使用过程中, 发现仪器有异味或有异常噪音时, 应立即切断电源。
- 实验室布局宜综合考虑高温高压等风险相对较高的设备的摆放。实验操作风险较高的实验室,可考虑设置监控和增加本实验室实验人员的培训频率。
