# 安全警示

## 实验室用电安全

## Laboratory Electrical Safety

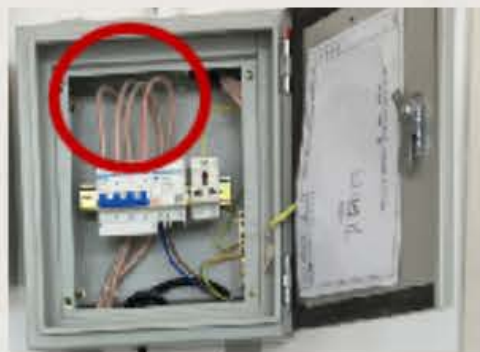
第三方误接火线与零线致短路

施工方误将配电箱内火线和零线接错，导致火线对零线短路，电路跳闸。

**根本原因：**第三方施工人员误操作将火线与零线接反

**建议：**加强第三方用电安全资质审核；加强非工作时间第三方安全作业管理；加强用电安全培训。

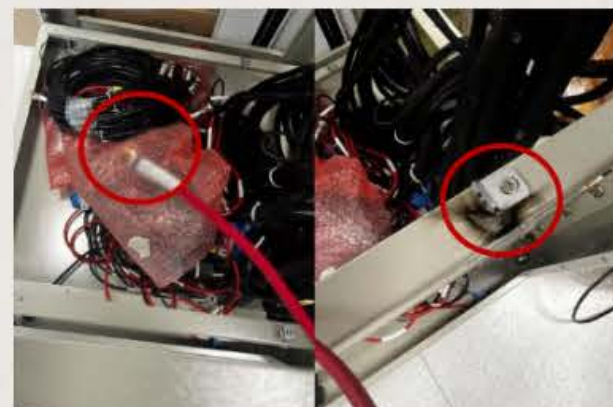
设备带电火线（380V）裸露导致跳闸

设备使用过程中，移动测试线时，牵引到裸露悬挂的火线（380V），该火线端子触碰铁架，出现火花，而后设备跳闸，电源空开跳闸。

- 设备厂家未正确安装，带电线路裸露
- 带电部件与易触及的金属部件或易触及表面之间未用双重绝缘或加强绝缘隔层。

1. 从源头把控设备线路安全；禁止设备裸露火线及其他电线！
2. 加强设备验收时电气线路安全检查，规范设备安全接线；
3. 加强设备绝缘及外围防护；
4. 加强线路安全标识，如危险线路、带电端子应有标识；
5. 加强人员用电安全培训。

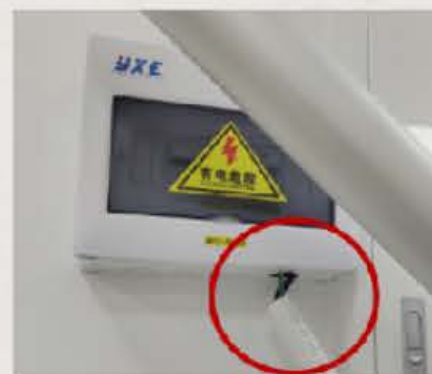
线路裸露

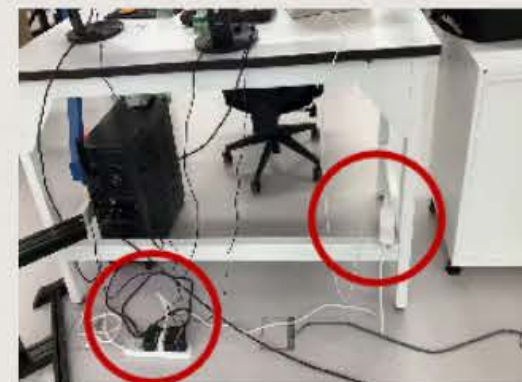
接线板串接、置于地面

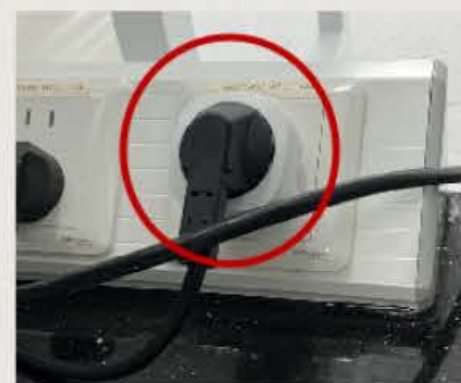
10A转16A存在风险

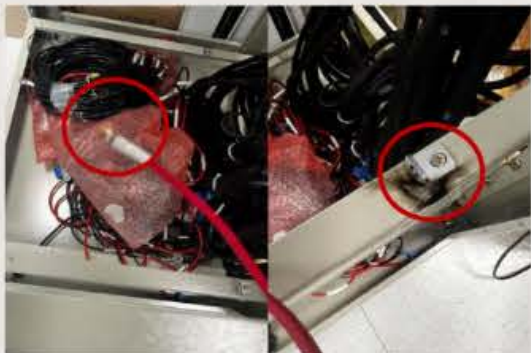
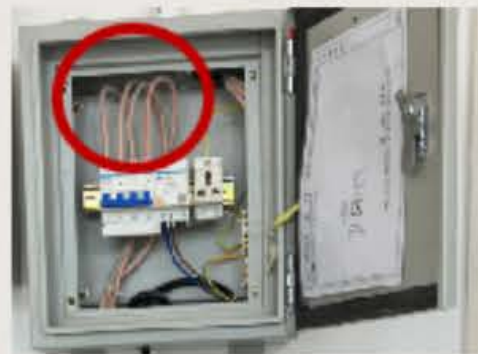
**Incident 2:** Exposed Live Wire (380V) Causes Tripping during Equipment Use

During equipment operation, movement of test cables dislodged an exposed hanging live wire (380V). The terminal of this live wire came into contact with an iron frame, causing sparks and subsequent tripping of both the equipment's power supply and circuit breaker.

- Exposed energized wiring on equipment due to error during installation by manufacturer.
- Lack of double insulation or reinforced insulation barriers between live parts and accessible metal components/surfaces.

Strengthen safety controls for equipment wiring design at the source. NO exposed live wires or other uninsulated wires! Tighten electrical line inspections during equipment acceptance; standardize safe wiring practices. Enhance insulation reinforcement & peripheral protection measures. Improve labeling for hazardous circuits/live terminals (e.g., warning signs). Expand staff training on electrical hazards.

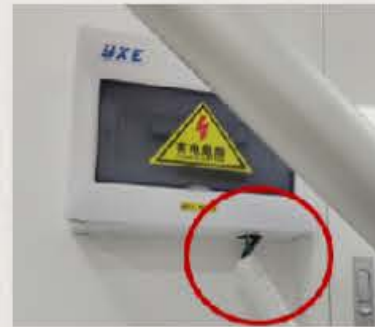
Exposed wiring

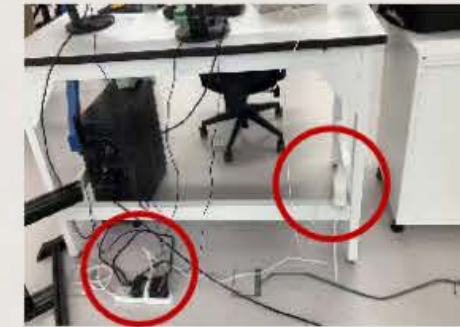
Daisy-chained power strips placed on floors

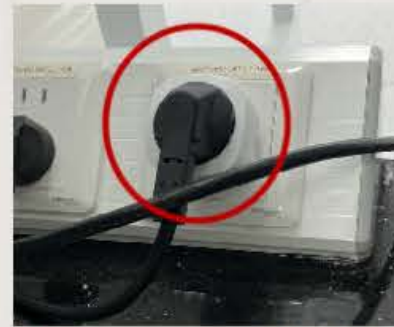
Improper use of 10A-to-16A adapters
