SAFETY ALERT

## 滤芯起火事故

NOV 24  
NO. 013

## Filter Cartridge Fire Accident

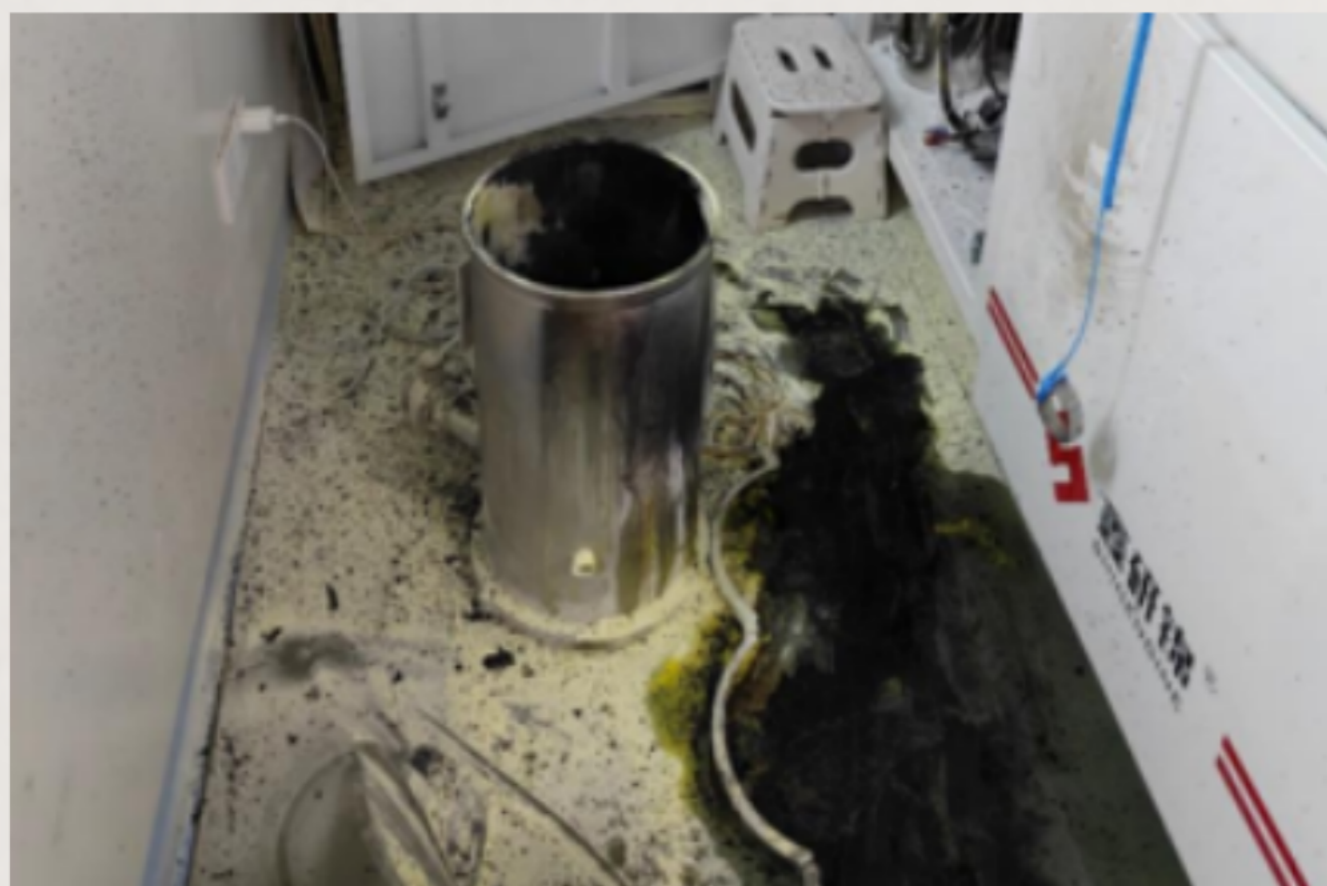
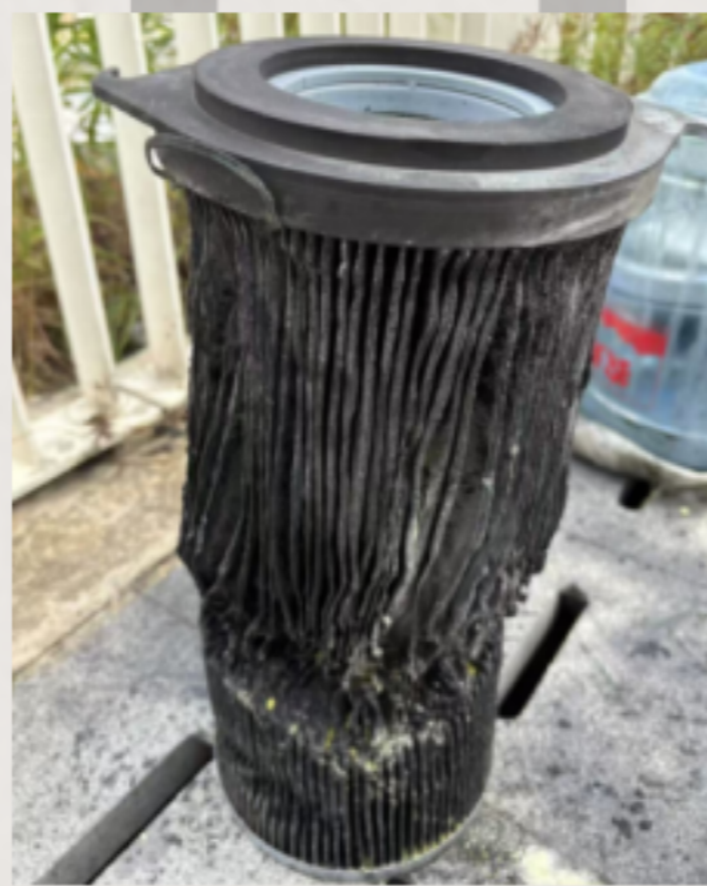
2025年9月25日下午，两名同学在更换金属激光3D打印设备烟尘过滤系统的滤芯时，一名同学计划使用垃圾袋盛装废滤芯，同时另一名同学从注满硅油的过滤桶中提出滤芯，在垃圾袋靠近提出滤芯的瞬间，滤芯内部燃烧。事故发生后，现场同学第一时间将明火扑灭，随后报告，安保人员到场后进行进一步处理。事故未造成人员伤亡。

滤芯中的钛、铌、镍、铝等合金金属粉末粒径小，有自燃和易燃特性，在用普通PE塑料袋盛装滤芯时，展开塑料袋过程中产生静电，与未完全钝化的金属粉末在空气中接触后，静电释放引燃金属粉末。

滤芯更换指引存在安全漏洞。厂家指引更换滤芯前使用10L硅油钝化2小时，可能存在硅油用量不足、浸润时间不充分的情况。

1. 实验室针对滤芯更换操作重新制定SOP和应急处置措施，并培训相关操作人员。
2. 将接地线延长，将滤芯更换场所从室内引出到走廊或门口空旷位置，现场拉好警戒，备好消防灭火器材和应急器材。
3. 再次确认钝化硅油的注入量，建议尽可能注满，硅油注入关闭蝶阀后，可缓慢晃动筒身，使硅油充分和粉尘混合包裹，然后静置，硅油的浸入时间应至少延长至6小时以上。
4. 收集废滤芯时，用金属或者塑料桶盛装大量防爆硅油来收集废滤芯。即在确保滤芯完全钝化后，将废滤芯从烟尘收集系统金属桶中取出立即放入大量硅油中浸没，再一起回收。
5. 针对金属激光3D打印设备进行风险评估，评估各环节的安全预控措施的充足性，并提出适当的改善建议。

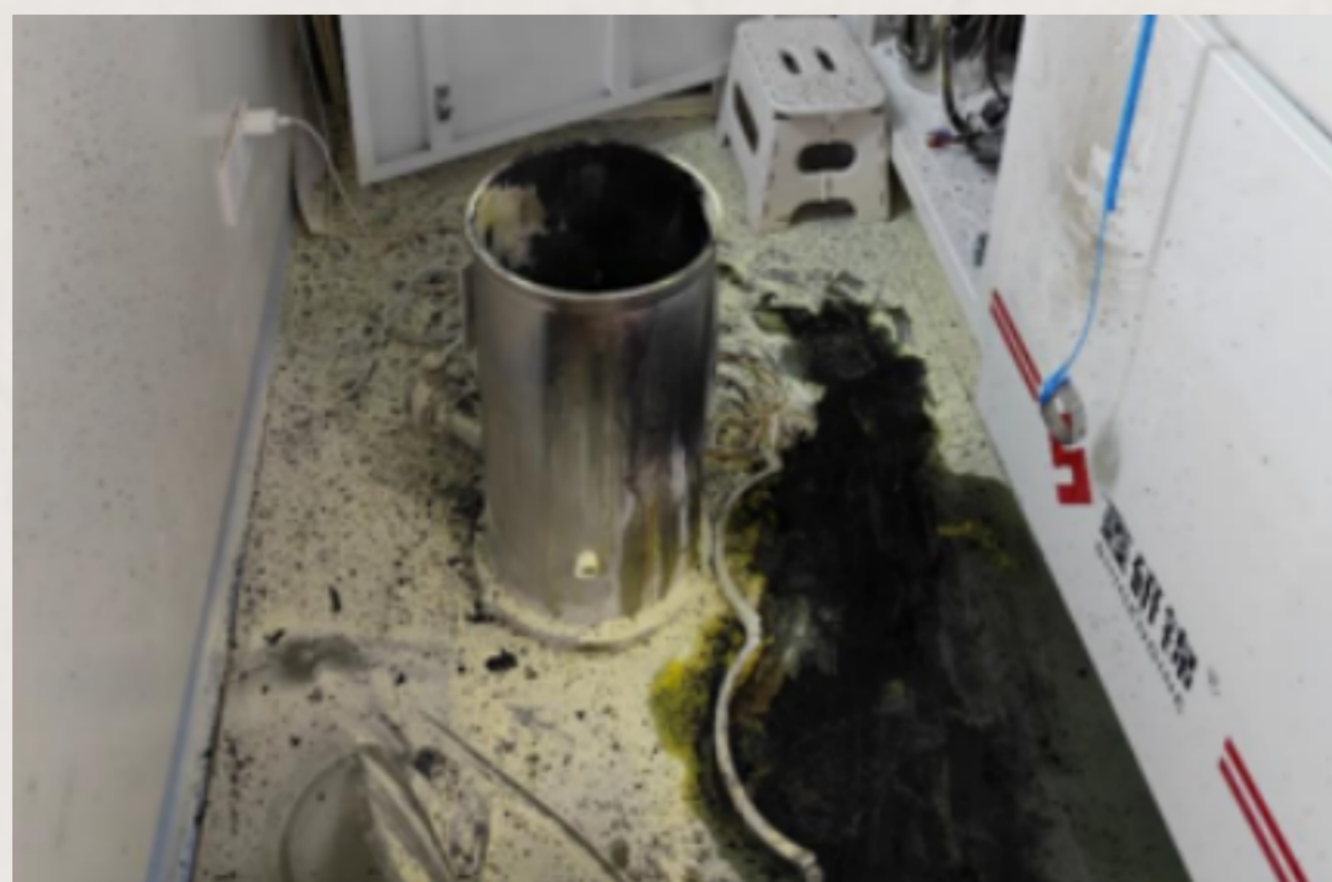
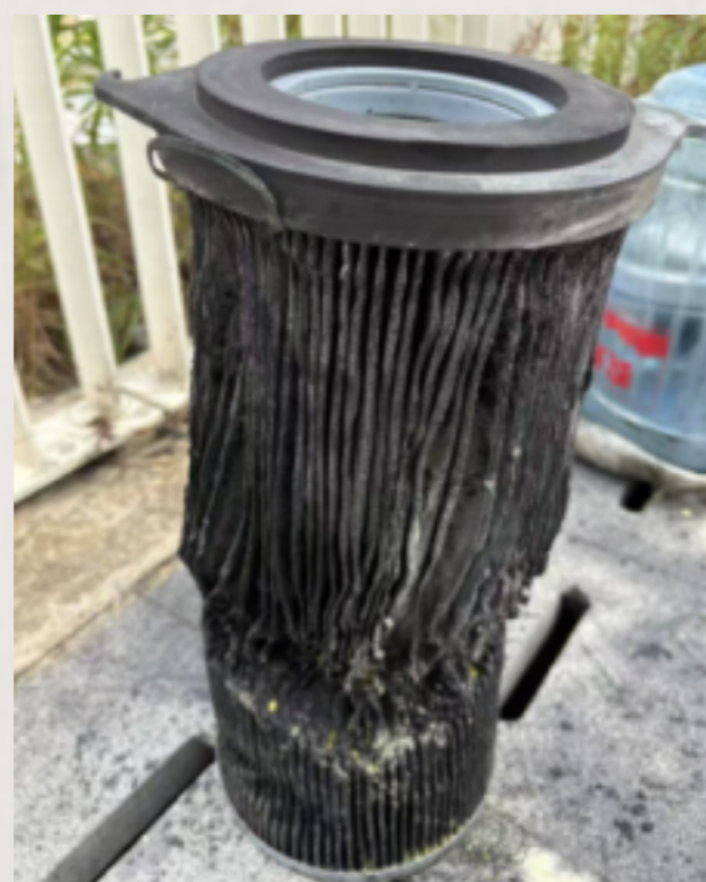
On the afternoon of September 25, 2025, two students were replacing the filter cartridge of the smoke and dust filtration system for metal laser 3D printing equipment. One student planned to use a garbage bag to hold the waste filter cartridge, while the other lifted the filter cartridge from a filter barrel filled with silicone oil. At the moment the garbage bag approached the lifted filter cartridge, the interior of the filter cartridge caught fire. Following the accident, the students on site extinguished the open flame immediately and reported the incident promptly. Security personnel arrived later for further disposal. No casualties were caused by the accident.

The alloy metal powders (such as titanium, niobium, nickel, and aluminum) in the filter cartridge have small particle sizes and possess spontaneous combustion and flammable characteristics. When using ordinary PE plastic bags to hold the filter cartridge, static electricity is generated during the process of unfolding the plastic bag. This static electricity discharges when it comes into contact with the incompletely passivated metal powders in the air, igniting the metal powders.

There are safety loopholes in the filter cartridge replacement guidelines. The manufacturer's guidelines require passivation with 10L of silicone oil for 2 hours before replacing the filter cartridge, but there may be cases where the dosage of silicone oil is insufficient or the soaking time is inadequate.

- 1.The laboratory shall re-formulate SOPs (Standard Operating Procedures) and emergency disposal measures for filter cartridge replacement operations, and conduct training for relevant operators.

- 2.Extend the grounding wire, move the filter cartridge replacement site from indoors to an open area such as a corridor or doorway, set up warning signs on site, and prepare fire-fighting equipment and emergency supplies.

- 3.Re-confirm the injection volume of passivation silicone oil; it is recommended to fill the barrel as much as possible. After closing the butterfly valve for silicone oil injection, the barrel body can be shaken slowly to ensure full mixing and wrapping of silicone oil with the dust, followed by standing still. The soaking time of silicone oil shall be extended to at least 6 hours.

- 4.When collecting waste filter cartridges, use metal or plastic buckets containing a large amount of explosion-proof silicone oil for collection. That is, after ensuring the filter cartridge is completely passivated, take it out from the metal barrel of the smoke and dust collection system and immediately immerse it in a large amount of silicone oil before recycling them together.

- 5.Conduct a risk assessment for metal laser 3D printing equipment, evaluate the adequacy of safety pre-control measures in each link, and put forward appropriate improvement suggestions.
